This guide is for repairing the corrugated line that carries washer fluid to the rear wiper on the A6 (C5) allroad and Avant models. Generally, this plastic line breaks somewhere between the body and hatch, resulting in little or no washer pressure, and / or leaks into the cargo area, and / or stains on the headliner. My dealer tacitly acknowledged that it is a known issue, and that it will be covered under the manufacturer's original or CPO warranty. For those of us out of warranty, it's a light- to medium-duty job and can be done in your driveway without too much hassle. Time needed is 15-60 minutes, depending on where the line has broken.

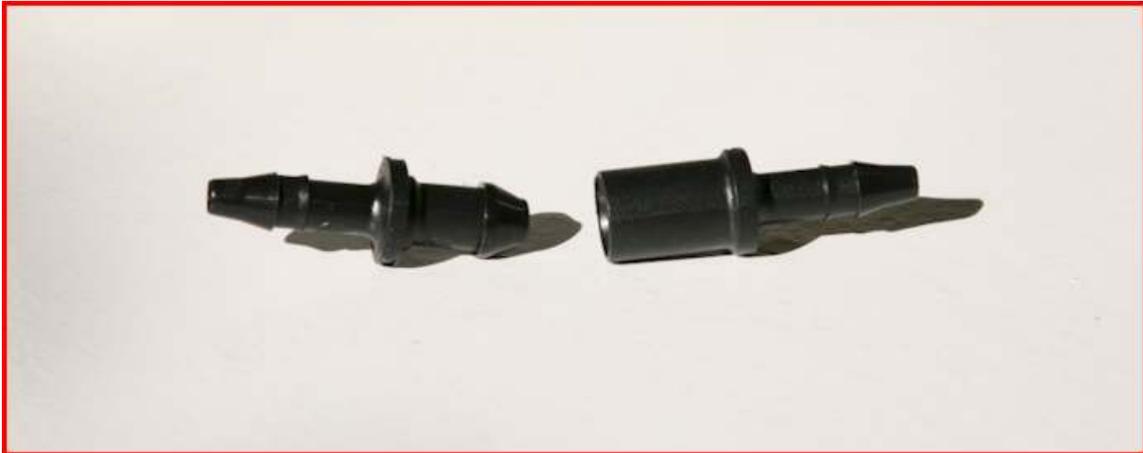
- 1 J0 955 875 R
- 1 J0 955 875

These cheapo plastic connectors would cost you fifty cents anywhere else but at the dealer, where they list the part for \$19 each (!!) but will sell them to you for \$9.50. They're available from online OEM parts sources for ~\$5 each, but you'll have to pay shipping. Pick your poison.

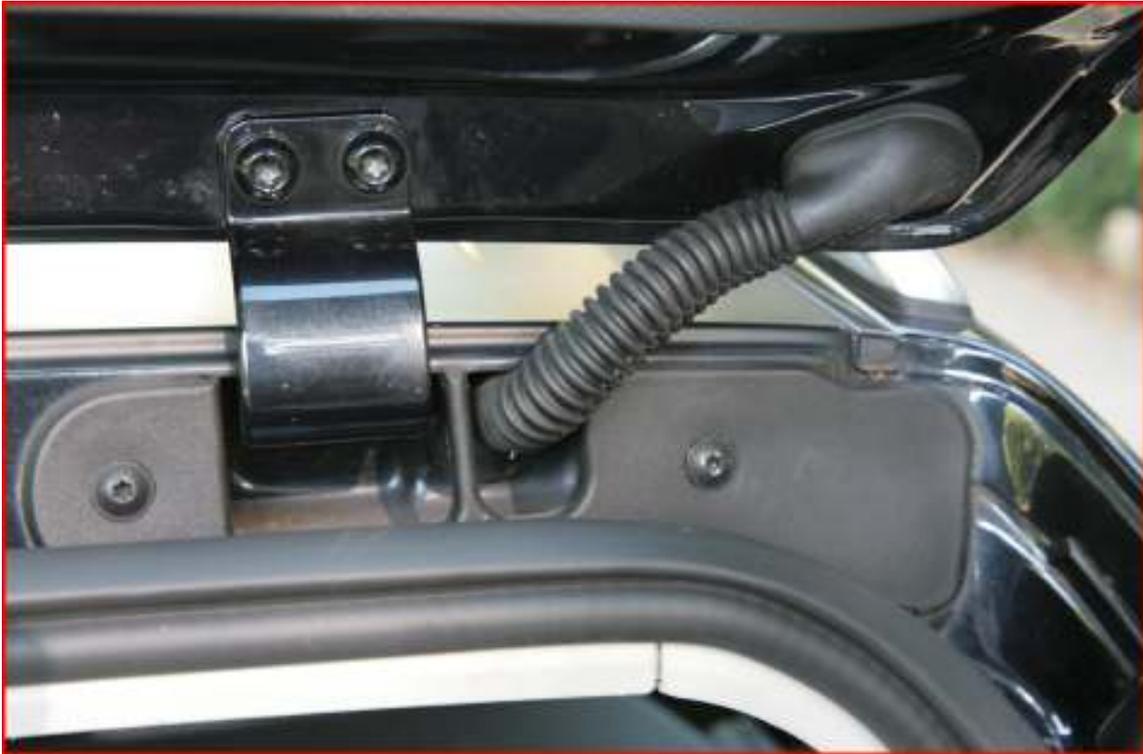
Here's what the work area looks like:

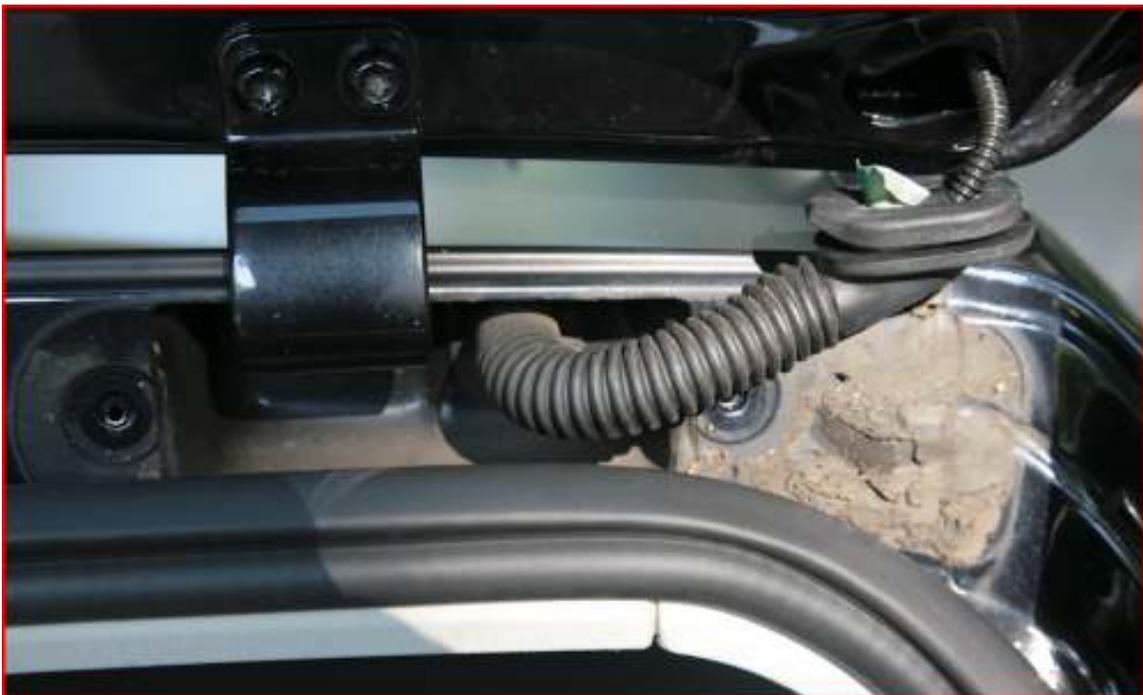
You will want to remove the plastic cover (two torx screws) to give yourself more room to work (note that I've also pulled the accordion hose from the hatch):

The hose runs all the way through the car and exits at the right rear hatch hinge. Gently pull the rubber accordion hose off the hatch as I have in the picture

above; it contains and protects the washer fluid hose. You'll note that the corrugated washer fluid hose is made of black plastic, and runs through an ~8" section of rubber hose to keep it from kinking. This 8" rubber hose covering runs from inside the hatch to inside the roof of the car. So, simply put, you have a triple layer hose setup to deal with:

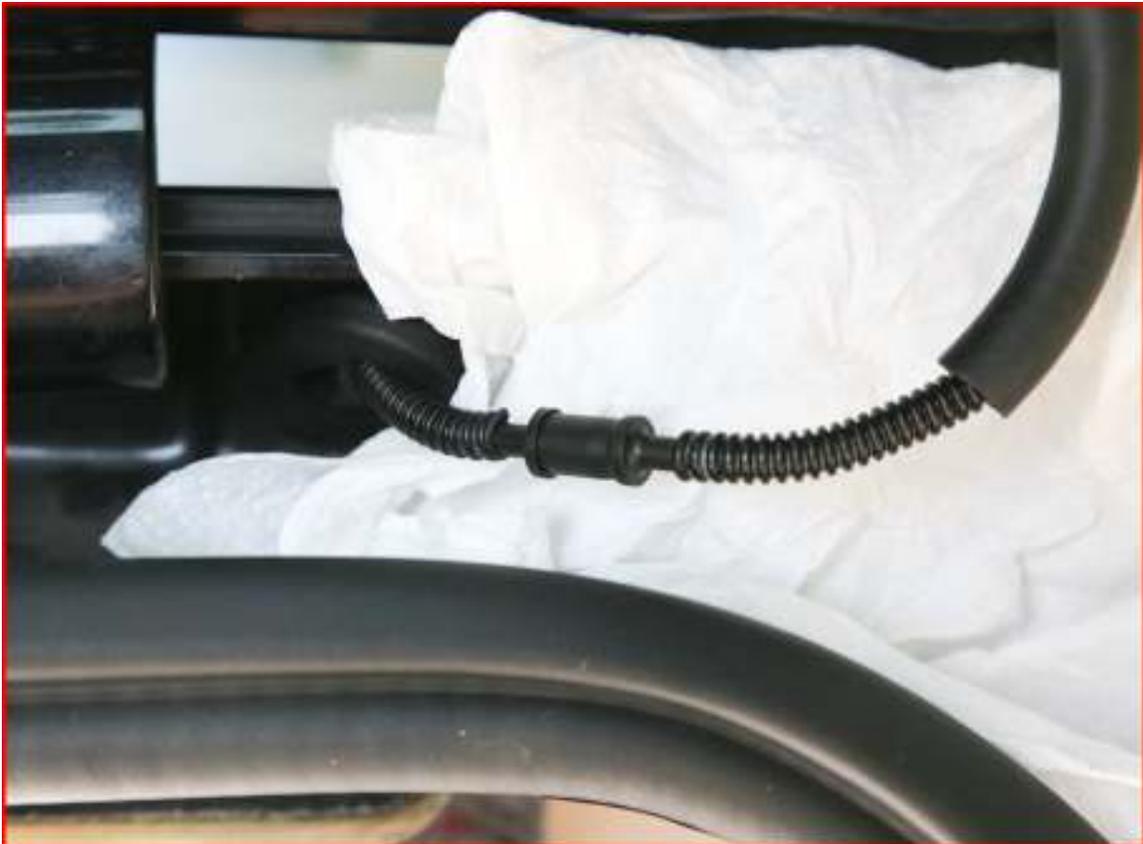
If your plastic hose broke close to the hatch, you're in luck. You'll probably have enough room to work to simply put the repair kit (the two \$9 connectors) in place, seal tightly with stretchy electrical tape (I prefer this to heat shrink tubing, as I didn't want to heat the plastic tubing, but to each their own), and pull the rubber hose and accordion cover back into place. Before it's wrapped and reassembled, the repair will resemble this:

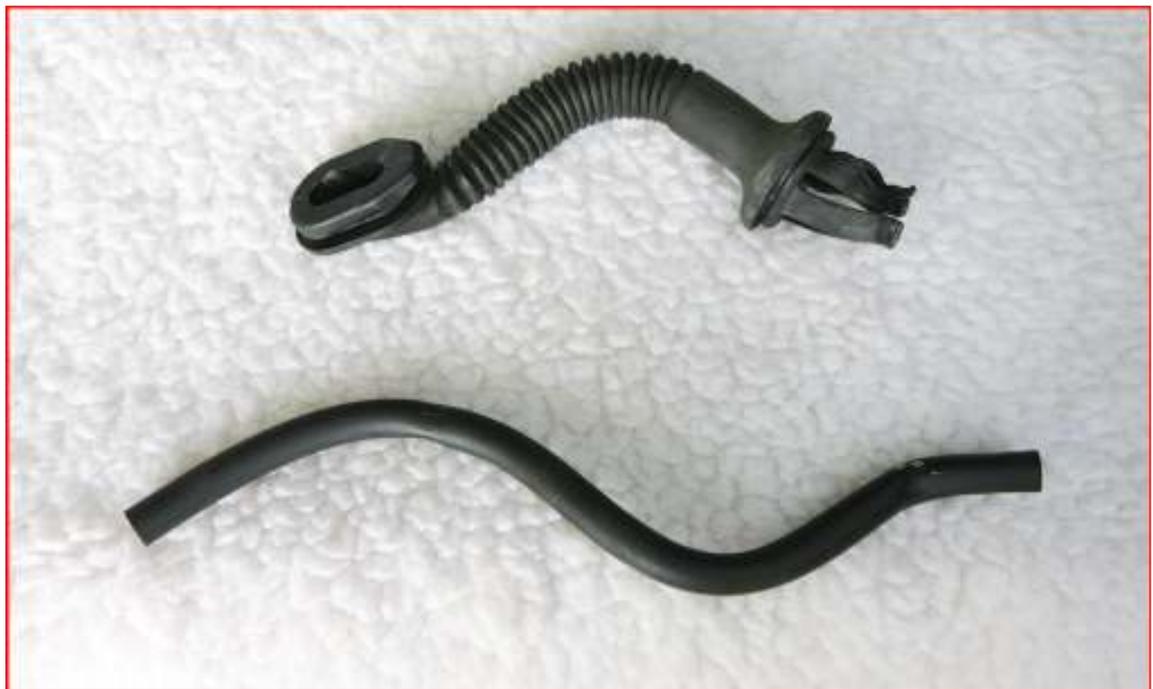
1. Remove the accordion hose from the hatch (outer layer)
2. Pull and remove the black rubber hose (middle layer) and set aside
3. Remove the accordion hose from the roof and set aside

Here's what you should have at this point: Outer and middle lines that have been removed:

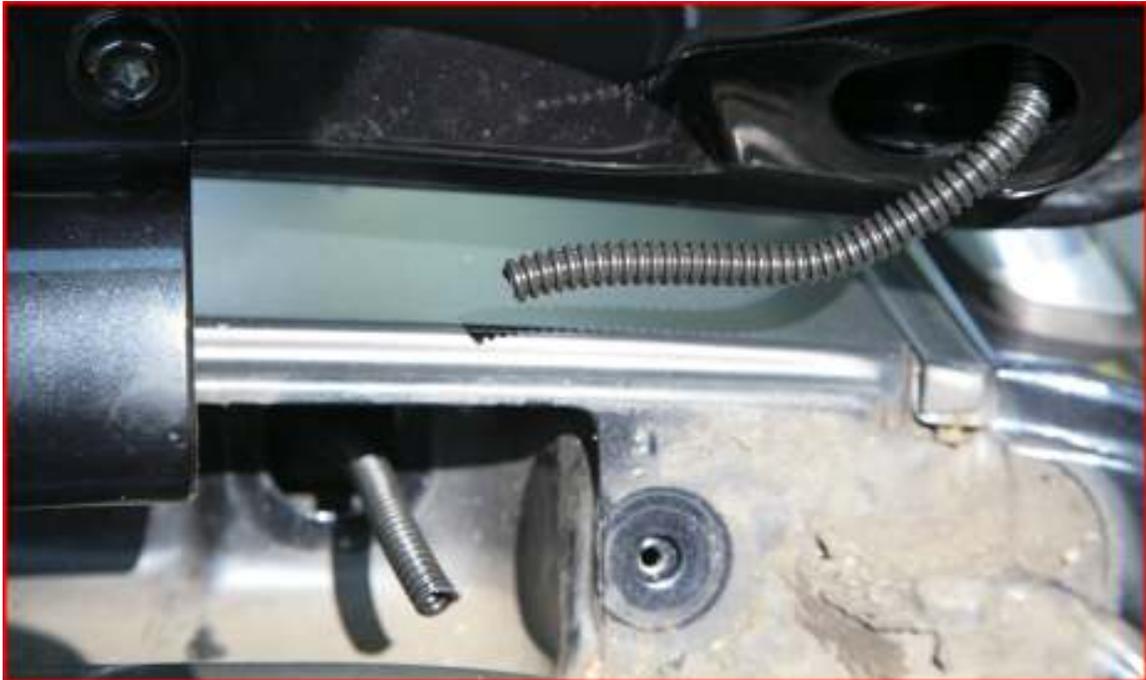
Exposed broken washer fluid line:

4. Note where the break in the washer fluid line (inner layer) is, and eyeball where it corresponds to on the black rubber hose (middle layer). This hose, when properly placed over the washer fluid line, will be roughly 40% in the hatch, and 60% in the car. Cut the rubber hose to correspond to where the break is.
5. Tie an 18" piece of thread or dental floss to each end of the broken corrugated washer fluid line.
6. Reinstall the black rubber hose on the washer fluid line. Use the thread as a way to pull the washer line through the hose or, alternatively, hold the washer line steady as you push the black rubber hose pieces back into place into the hatch and roof. Push the rubber hose pieces an extra inch or so up the washer line to give yourself room to work. See picture below:

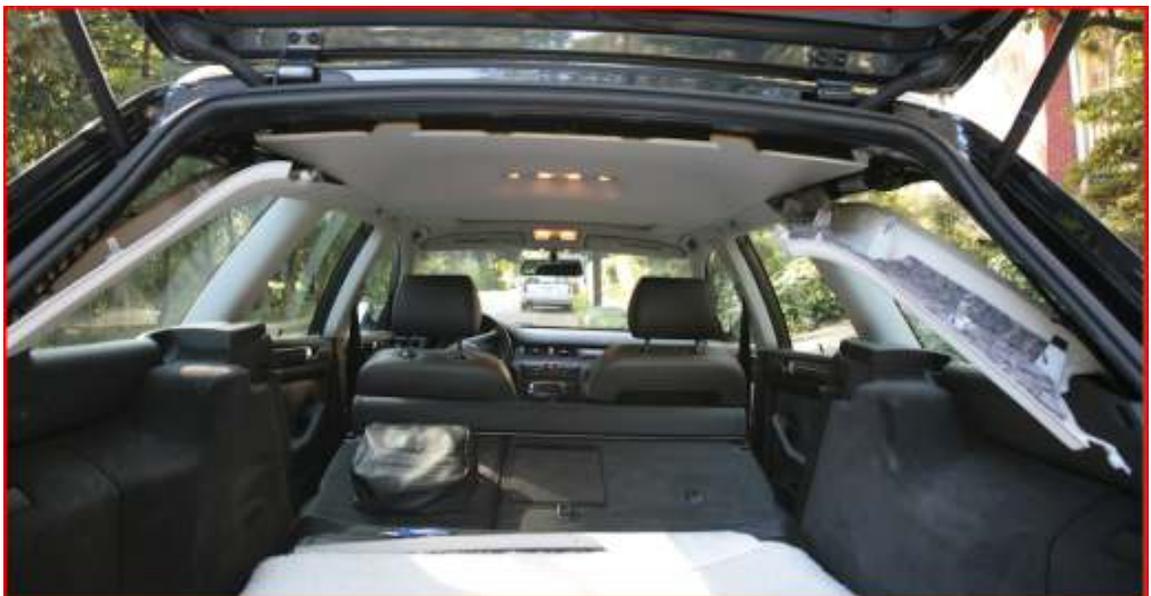
8. NOTE: you do not have to completely remove the D-pillar trim. This is the state of disassembly that I left things in:

7. Remove the upper interior trim / headliner ("roof frame trim") near the rear hatch following the instructions kindly provided by fellow allroader want:

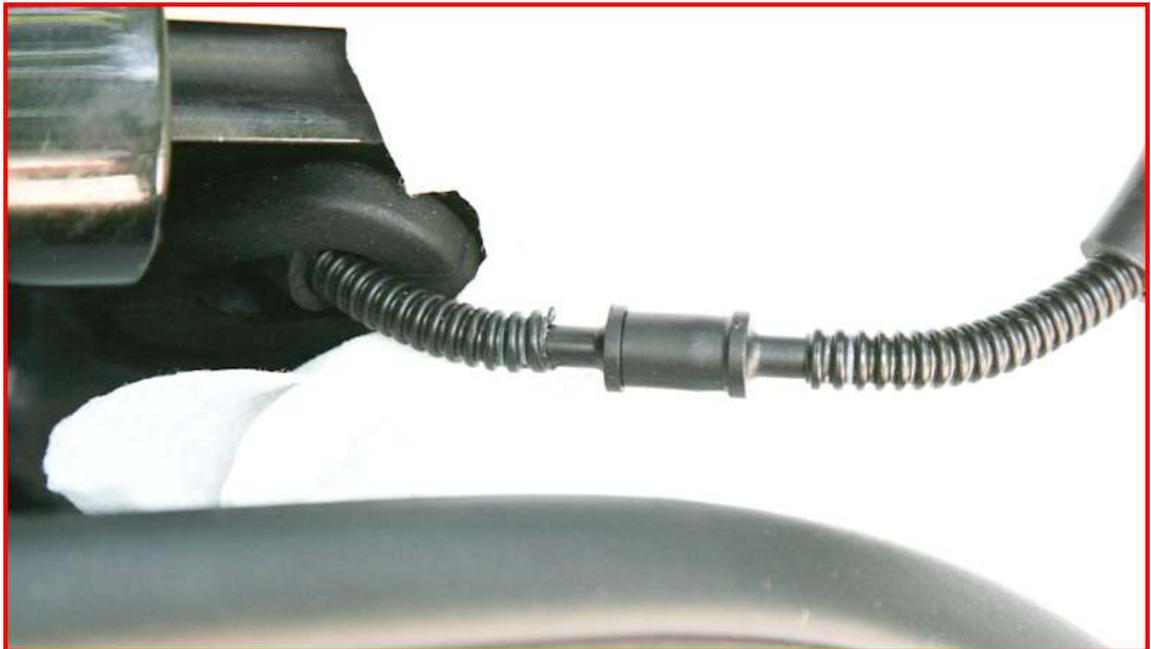
In the left-hand side of the picture below, you can see just the leading edge of the accordion hose. The rest is inside the roof area:

9. Gently thread the accordion hose onto the washer line coming out of the roof. Make sure that the hose is oriented correctly, i.e. lined up the same way it was originally installed (four floppy “fingers” towards the front of the car). Push the hose through the hole in the roof (“slide the pipe further up the line”), making sure that you are not stressing the corrugated line inside the car and that you have sufficient washer line outside the roof. Stop when you have enough room to install the connector kit.

10. Remove thread from washer fluid line ends
11. Make sure that broken ends of the washer line are cut flat, then install the connector kit, and, finally, test for leaks. Readjust and tighten as necessary.
12. Tightly cover the connection and the incoming / outgoing washer line with electrical tape (or heat shrink tubing)
13. Pull the black rubber hose halves (middle layer) back into place and onto the connector kit.
14. Gently pull the accordion hose out of the roof. Getting the last portion with the grommet through the roof hole will be tough, but it is doable. Be careful not to rip the hose. Reseat end of the accordion hose grommet
